By J. Baun, BS, RDMS, RVT, FSDMS

## Triplex Ultrasound Evaluation of Late Failure Hemodialysis Access Fistulae

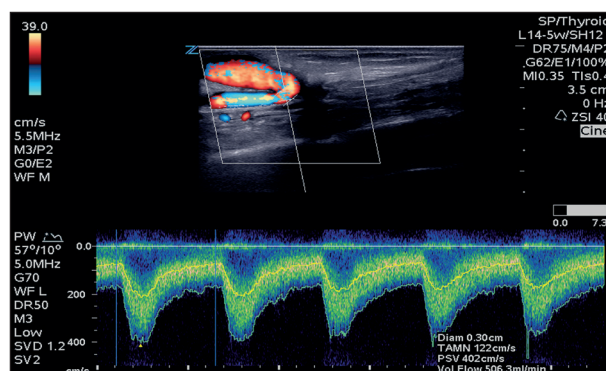
**FIGURE 1.** Triplex findings at a normal anastomosis. PSV 402 cm/sec, Volume flow 506 mL/min.

A mature and adequately functioning AVF delivers  $\geq 600$  mL/min; typical dialysis device exchange volumes require between 300-500 ml/min.. Triplex ultrasound examination is the optimal method for the evaluation of the adequate functioning of the AVF [Figures 1 and 2]

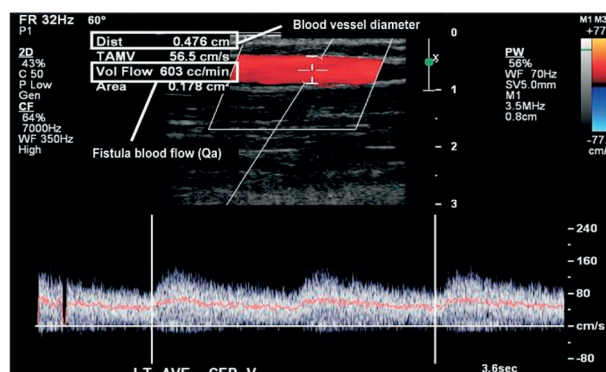
**FIGURE 2.** Normal mid-graft triplex findings. PSV 120 cm/sec, volume flow 603 mL/min.

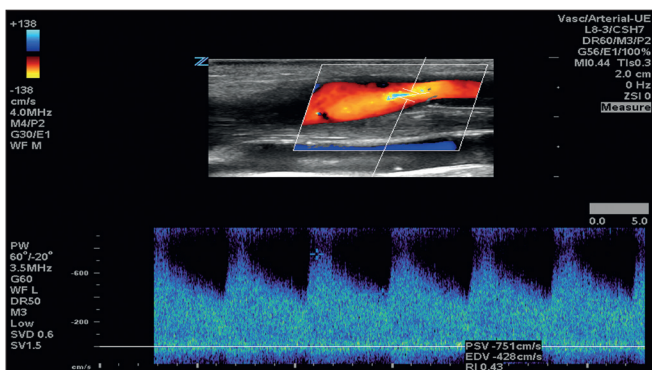
**FIGURE 3.** Triplex findings in a mid-graft stenosis. CDI-directed PW Doppler demonstrate PSV >700 cm/sec, EDV >400 cm/sec.

The main cause of late failure is vascular stenotic lesions leading to decreased flow volume, inadequate dialysis and eventual occlusive thrombosis. Most stenotic lesions occur at or near the arterial anastomosis. However, focal lesions may also occur at the site of repeated needle cannulation. [Figure 3] Thrombosis in the central venous outflow tract (cephalic venous arch) can also lead to AVF dysfunction and eventual failure. Other causes of failure include vascular steal and aneurysms [2].

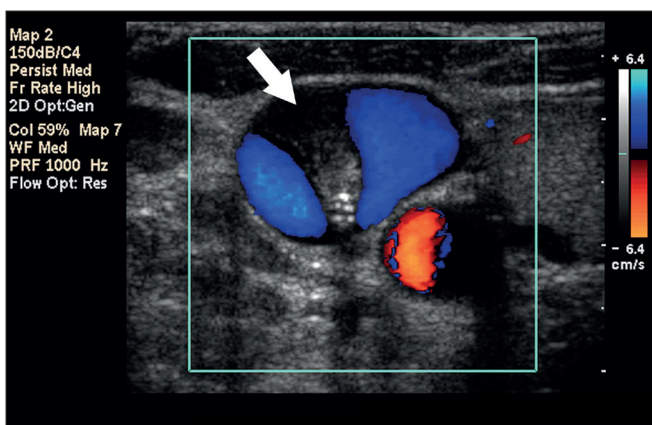
**FIGURE 4.** Venous outflow thrombosis. Non-occlusive echogenic clot is seen in the central lumen of the internal jugular vein (arrow)..

Identification of significantly stenotic areas either at the anastomosis or along the length of the AVF is accomplished using CDI-directed PW Doppler criteria [Table 1]; venous outflow stenoses are best assessed with B-mode imaging. [Figure 4]. Frequently, ultrasound findings alone can provide the information necessary to make patient management decisions and plan any intervention necessary to salvage an AVF. This is particularly true for anastomotic and upstream areas. Identification of thrombosis or stenosis in the venous outflow conduits in the axilla or neck usually requires a contrast fistulogram for further assessment.
