# Essentials of **Sonographic Image Interpretation**

FOUNDATIONS FOR CONFIDENT,  
CLINICALLY RELEVANT ULTRASOUND ANALYSIS

## ***Introduction***

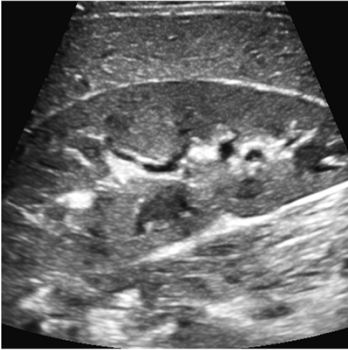
Smoothly margined  
Well-defined

Renal capsule

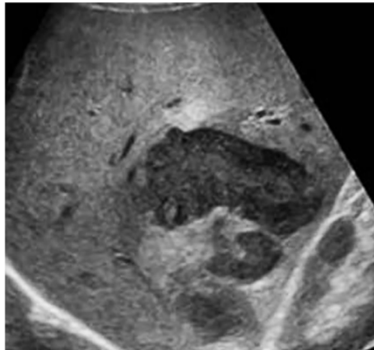
Irregularly margined  
Well-defined

Liver abscess

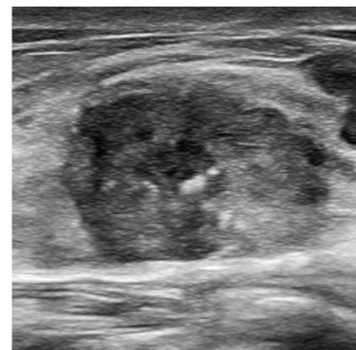
Irregularly margined  
Poorly-defined

Breast malignancy

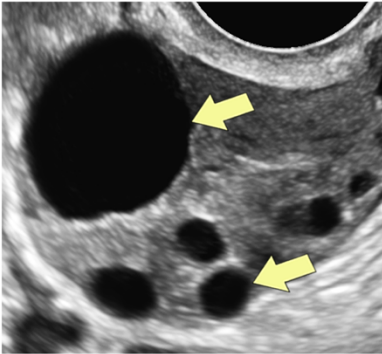
Anechoic - Sonolucent

Ovarian follicles

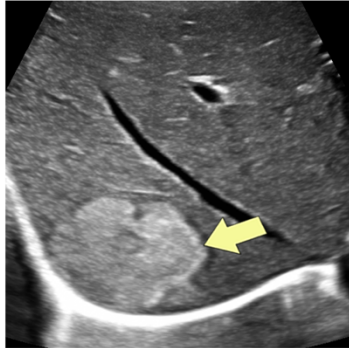
Hyperechoic

Hepatic hemangioma

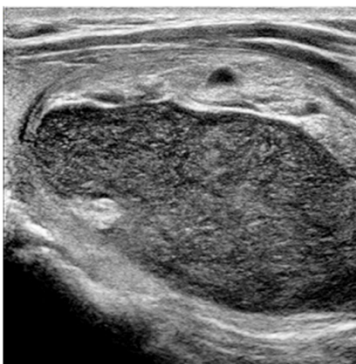
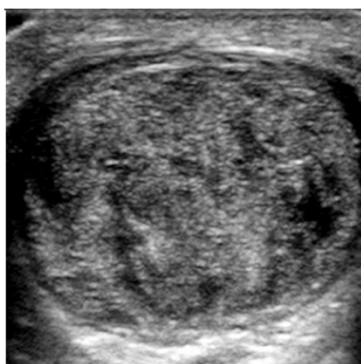
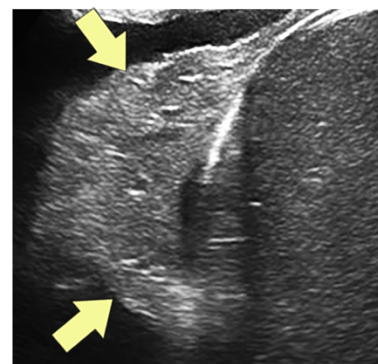
## Heterogeneous - Image Examples

Thyroid nodule

Inflamed Achilles tendon

Consolidated lung

It is also important to characterize the distribution and arrangement of the internal echoes within a structure. Generally, a structure that contains a mix of hyperechoic and hypoechoic areas, would be described as **heterogeneous**. Heterogeneous structures may also contain anechoic areas and specular reflections arranged in a seemingly random pattern. If a structure appears uniformly echogenic (*hypoechoic or hyperechoic*) then it is described as **homogeneous**. In organs or structures with a homogeneous internal echo pattern, the histological (*tissue*) appearance is very uniform. Heterogeneous areas in an otherwise homogeneous organ usually represent areas with different underlying tissue architecture such as areas of hemorrhage, necrosis, fat, or fibrin deposition. Typical sonographic examples of heterogeneous appearance correlating with pathological appearance include uterine myomata (*fibroids*) and teratomas.

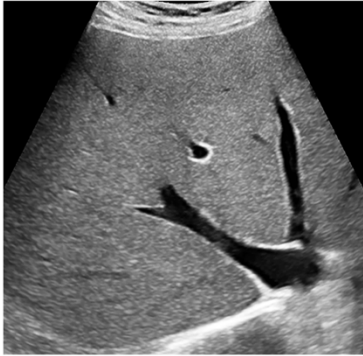
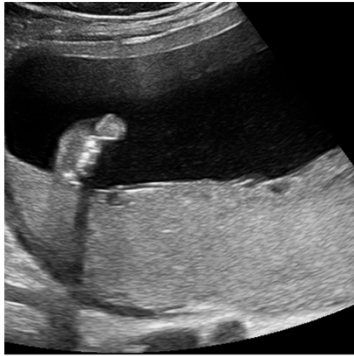
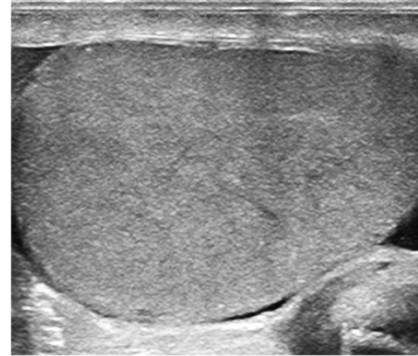
## Homogeneous - Image Examples

Normal liver tissue

Normal placenta

Normal testicular tissue

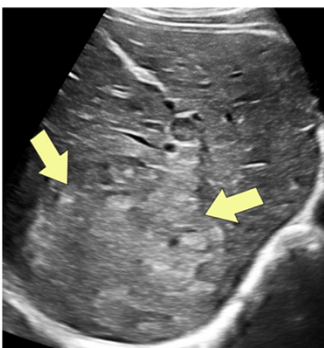
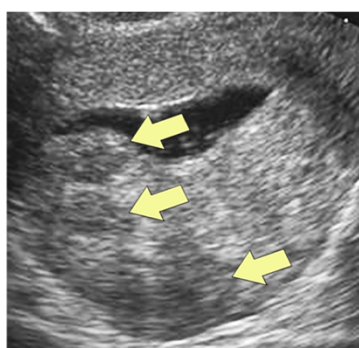
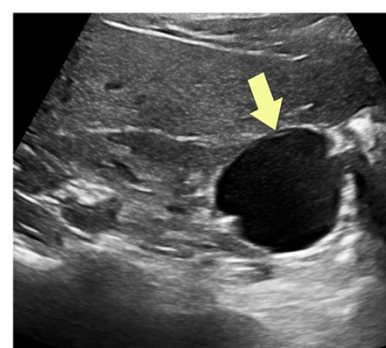
## Focal Imaging Findings

Liver tumor  
(Hepatocellular carcinoma)

Focal uterine fibroids

Renal cyst

Alterations in the contour and internal echo pattern associated with a solid structure can further be described as either focal or diffuse. This distinction provides significant information about pathological changes that may be present, particularly in solid parenchymal organs. In a **diffuse** presentation, alterations in sonographic appearance are dispersed evenly throughout a structure and typically represent histological changes that affect the entire organ. Examples include fatty infiltration or cirrhotic changes in the liver, testicular microlithiasis, and diffuse inflammatory diseases. A **focal** sonographic finding describes a region in a solid structure that is discrete, well-marginated and of differing echogenicity than that of the surrounding tissue. Focal changes may present as hyper-, hypo-, anechoic or any combination thereof. As one would expect, they are associated with localized alterations in tissue composition. Examples include benign and malignant liver tumors, uterine fibroids, and cysts.

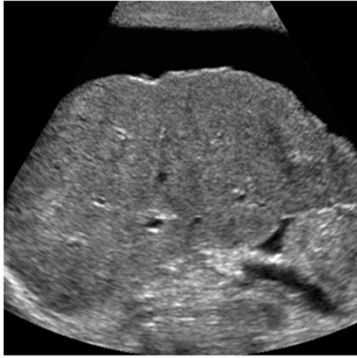
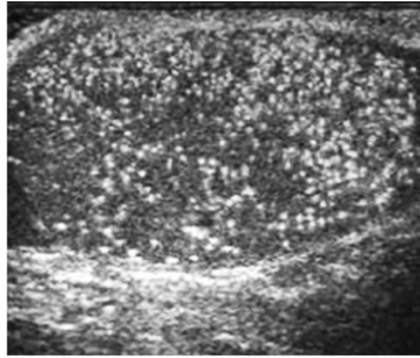
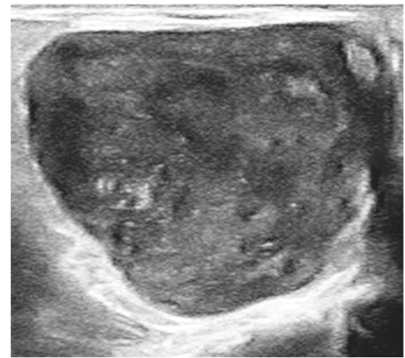
## Diffuse Imaging Findings

Cirrhotic liver

Testicular microlithiasis

Abdominal lymphoma

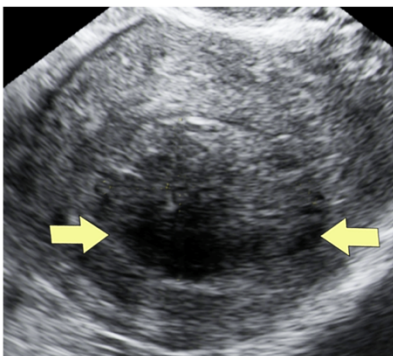
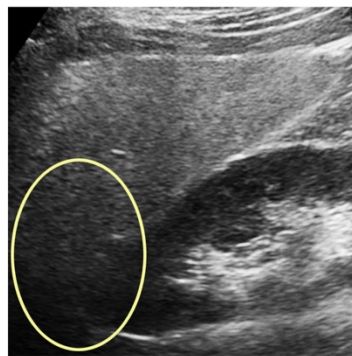
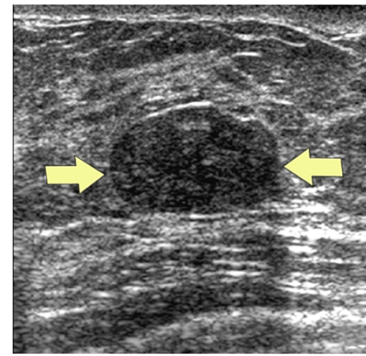
### Hyperattenuation - Image Examples

Uterine fibroid

Fatty liver

Solid breast lesion

An excellent example of a hyperattenuating structure is a uterine fibroid. While the gross pathology of a fibroid is that of bundles of striated muscle fibers arranged and running in random directions, the sonographic appearance is not consistent with that seen in the normal uterine myometrium (*muscular layer*). In fact, in most fibroids, it is impossible to obtain any sonographic detail about the internal architecture of the mass at all. Rather, fibroids appear as hypoechoic masses that attenuate ultrasound rapidly. This appearance is the result of the abnormal and eccentric muscle-tissue bundles, running randomly and frequently in arcs or circles, reflecting, refracting, and scattering significant quantities of the ultrasound beam at these curved interfaces. This increased internal refraction contributes to an overall increase in attenuation with a resultant hypoechoic, solid appearing mass. Other common clinical examples of hyperattenuating structures include fatty infiltration of the liver and solid neoplastic lesions.

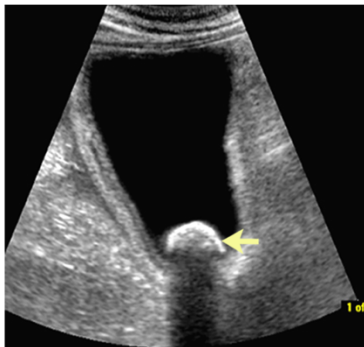
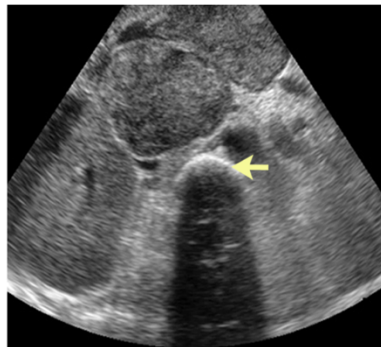
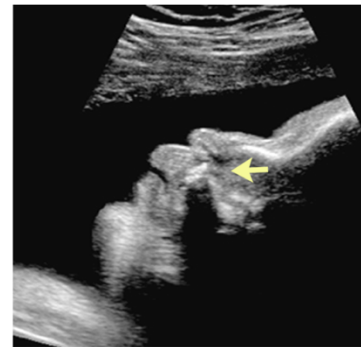
### Posterior Acoustic Shadowing

Gall stone

Vertebral body

Fetal maxilla

The presence of an acoustic shadow provides useful information about the composition of the structure from which it originates. The most common source of a shadow is the presence of calcium or other highly attenuative materials such as cholesterol, lipids, and uric acid crystals. Calcium is universally present in bony structures and is a common component of some types of calculi (*stones*) in the kidneys and gall bladder. It is also a frequent component of various neoplastic and chronic inflammatory processes. Some clinical examples of pathologic entities that cast a posterior acoustic shadow include atheromatous arterial plaques, teratomas, chronic abscesses, and chronic pancreatitis.

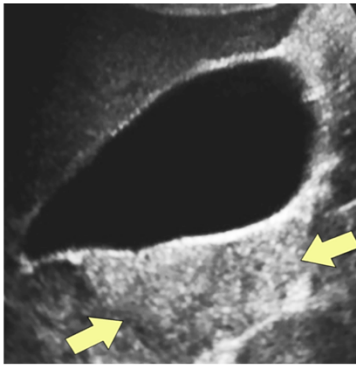
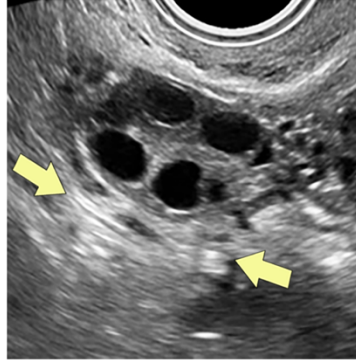
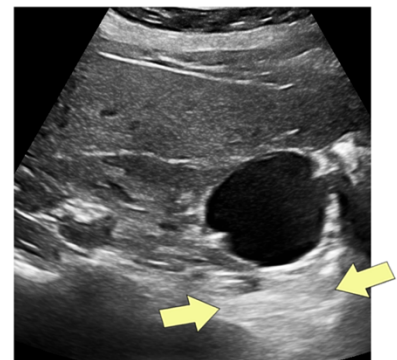
### Posterior Acoustic Enhancement

Behind the gall bladder

Behind a normal follicle-containing ovary

Behind a renal cyst

**Posterior acoustic enhancement** is a physical phenomenon opposite to shadowing. As an acoustic beam of given amplitude encounters a structure that is less attenuating than adjacent soft tissue, it continues to propagate through the structure unimpeded. As the beam exits the structure, the intensity remains strong enough to produce high amplitude echoes as it encounters interfaces deep to the structure. As a result, the echogenicity of the area behind the structure appears increased compared to adjacent tissue areas. This area of increased echogenicity is called an area of posterior acoustic enhancement or of “enhanced through-transmission”. Posterior acoustic enhancement is strong evidence of the presence of a fluid-filled structure and is normally seen, for example, behind the gall bladder or a simple cyst. The presence of enhancement behind

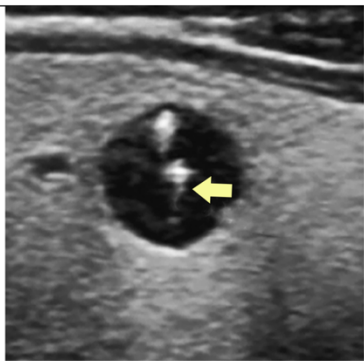
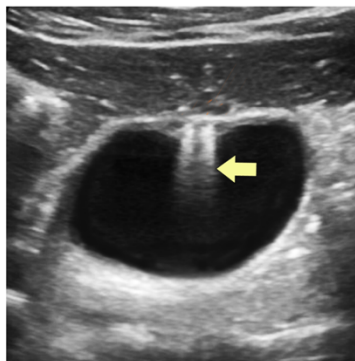
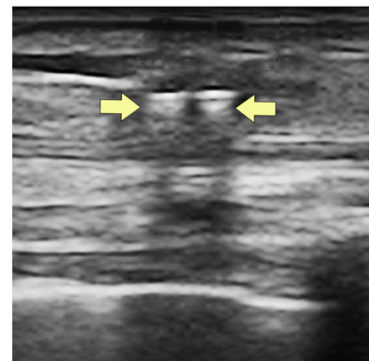
### Comet Tail Artifact

Thyroid colloid cyst

Gall bladder adenomyomatosis

Subcutaneous surgical clips

**Comet-tails** are a variant of conventional reverberation artifacts. They originate from small, highly reflective interfaces that are too closely spaced to be resolved individually. As a result, the displayed “ringing” from these robust reflectors appears as a high amplitude “tail”, not the equally spaced, linear artifacts associated with reverberation. Additionally, attenuation of the continued ringing results in a progressive diminution of both amplitude and width creating the tapering, echogenic triangle that resembles a comet tail. They are more frequently seen in otherwise anechoic areas on an image. Comet-tail artifacts are clinically useful, particularly in identifying cholesterol crystals in adenomyomatosis of the gallbladder or inspissated colloid in benign colloid nodules of the thyroid. They may also be seen with small calcifications and metal objects, such as foreign bodies and surgical clips.

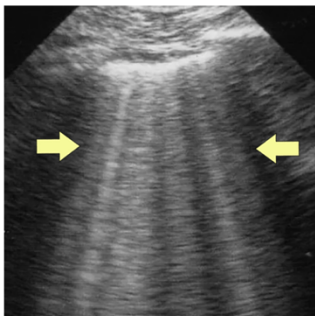
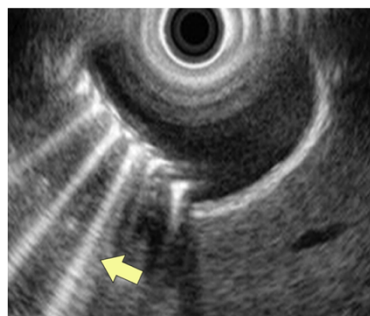
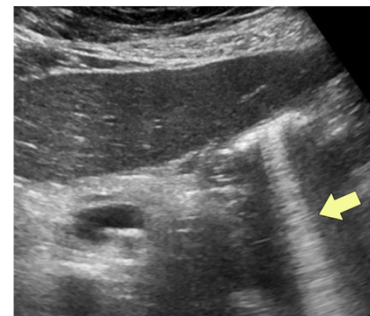
### Ring-down Artifact

Lung/pleura interface

Gall stones - endoscopic

Gas in duodenum

**Ring-down artifact** is similar in nature to comet-tails, but the causative mechanism is completely different. When an acoustic wavefront encounters small air bubbles trapped within a fluid collection, the bubbles begin to oscillate. This physical response is similar to that which occurs between acoustic energy and the microbubbles used in contrast-

enhanced ultrasound. The resonating air bubbles create both nonlinear and harmonic responses which, in contrast-enhanced ultrasound applications, can be captured, processed, and put to good use. In grayscale imaging, however, these resonant vibrations produce a continuous, though decaying, stream of acoustic energy displayed on the image as a fuzzy streak deep to the point source. Ring-down artifact is only associated with gas bubbles enclosed within a fluid collection. As such, they can be useful in identifying the abnormal presence of air that may be associated with pathological conditions such as pneumoperitoneum, portal venous gas, and emphysematous (*gas-forming*) infections and abscesses.

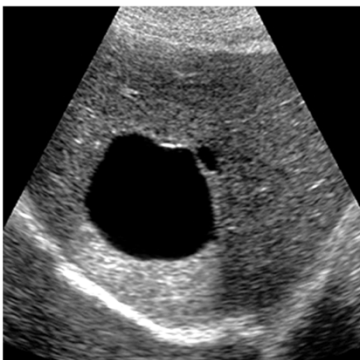
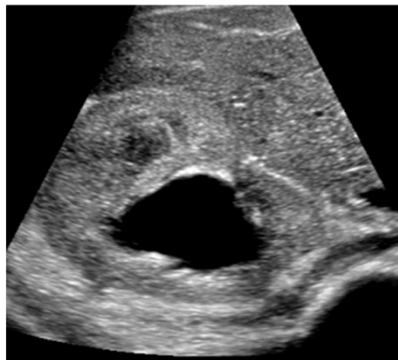
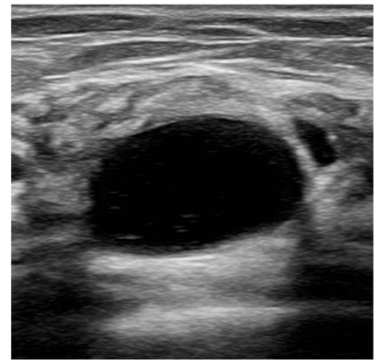
### **Cystic - Image Findings**

Liver cyst

Dilated renal pelvis  
(hydronephrosis)

Breast cyst

Cystic structures are fluid-filled. Examples of normal cystic anatomical structures in the body include the urine-filled bladder, the eye, and a normal gallbladder. Cystic structures are usually smooth-walled and have well-defined borders. The content of simple cystic structures in the body is essentially water-based regardless of whether the source is exudate, transudate, or an excretory by-product. There may be biochemical variations in the composition of these fluids, but they all behave acoustically like water. Because the content of a cystic structure is by nature a homogenous fluid, there are no acoustic interfaces within to generate echoes leaving the structure echo-free or anechoic. The presence of posterior acoustic enhancement behind the cyst confirms the fluid-filled nature of the structure being imaged.

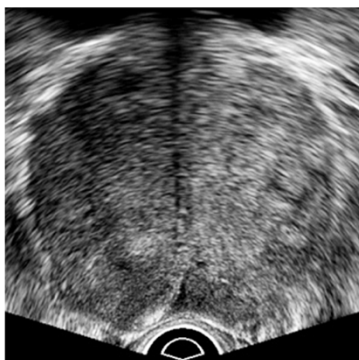
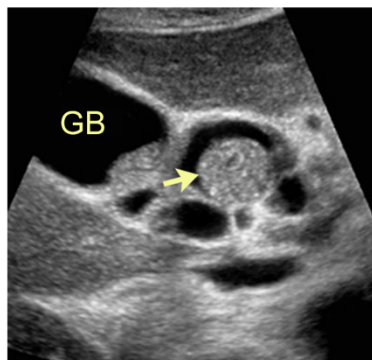
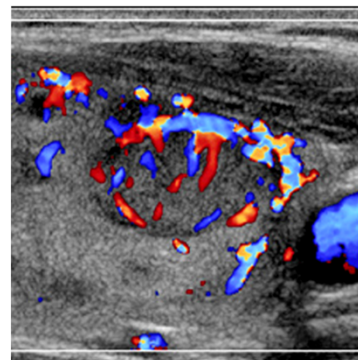
### Solid - Image Findings

Normal prostate gland  
(transrectal imaging)

Solid bile duct tumor

Vascularized thyroid nodule

The accompanying images demonstrate sonographic findings associated with several different solid structures. It is the appearance of internal echoes and the absence of posterior acoustic enhancement that characterize a solid structure on sonographic images. Solid structures come in all shapes, sizes, and contours. Generally, smooth-walled solid structures have a specular boundary that can be demonstrated, whereas solid structures with irregular, poorly defined walls or margins do not. The boundary between a solid lesion within a solid organ (*such as some tumors in the liver*) can sometimes be discriminated only by the difference in texture between the normal liver parenchyma and the tumor.

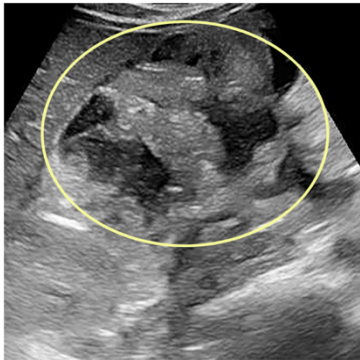
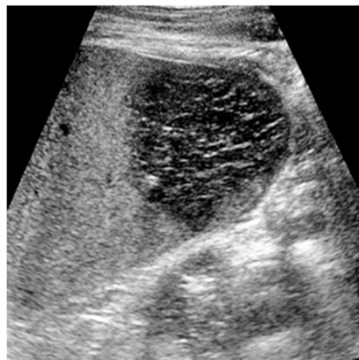
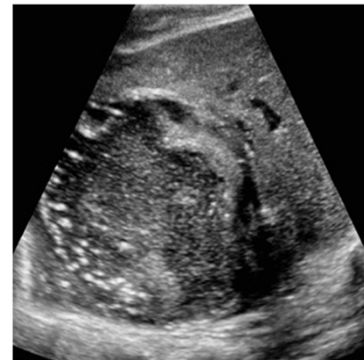
### Complex - Image Findings

Ruptured gall bladder

Hematoma in splenic capsule

Necrotic metastatic tumor  
in the liver

A predominantly cystic structure may be called complex if it contains multiple septations, a dependent debris level, or solid elements projecting into its lumen. An otherwise solid structure may be termed complex if it contains areas of fluid within it due to areas of liquefactive necrosis or liquefied (*lysed*) hemorrhage. Some lesions have a complex sonographic appearance by their very nature, such as dermoid tumors, which contain multiple tissue elements, some of which may be cystic and others solid. As with cystic and solid masses, it is important to describe the shape and appearance of the boundary of the mass. It is also important to attempt to characterize the boundaries of the cystic or solid elements within a complex lesion. Sound transmission characteristics behind complex masses vary depending on the path of the ultrasound beam. If the beam passes through a predominantly cystic area, there will be posterior acoustic enhancement of the acoustic energy sound behind the mass in this area, while there may be evidence of acoustic attenuation distant to another area of the mass that is composed primarily of solid tissue.
